# New Bedford Regulator Specification Sheet

**Regulator #:** R-013A

**Location:** Aquidneck St. at E. Rodney French Blvd.

**Date:** 6/25/25

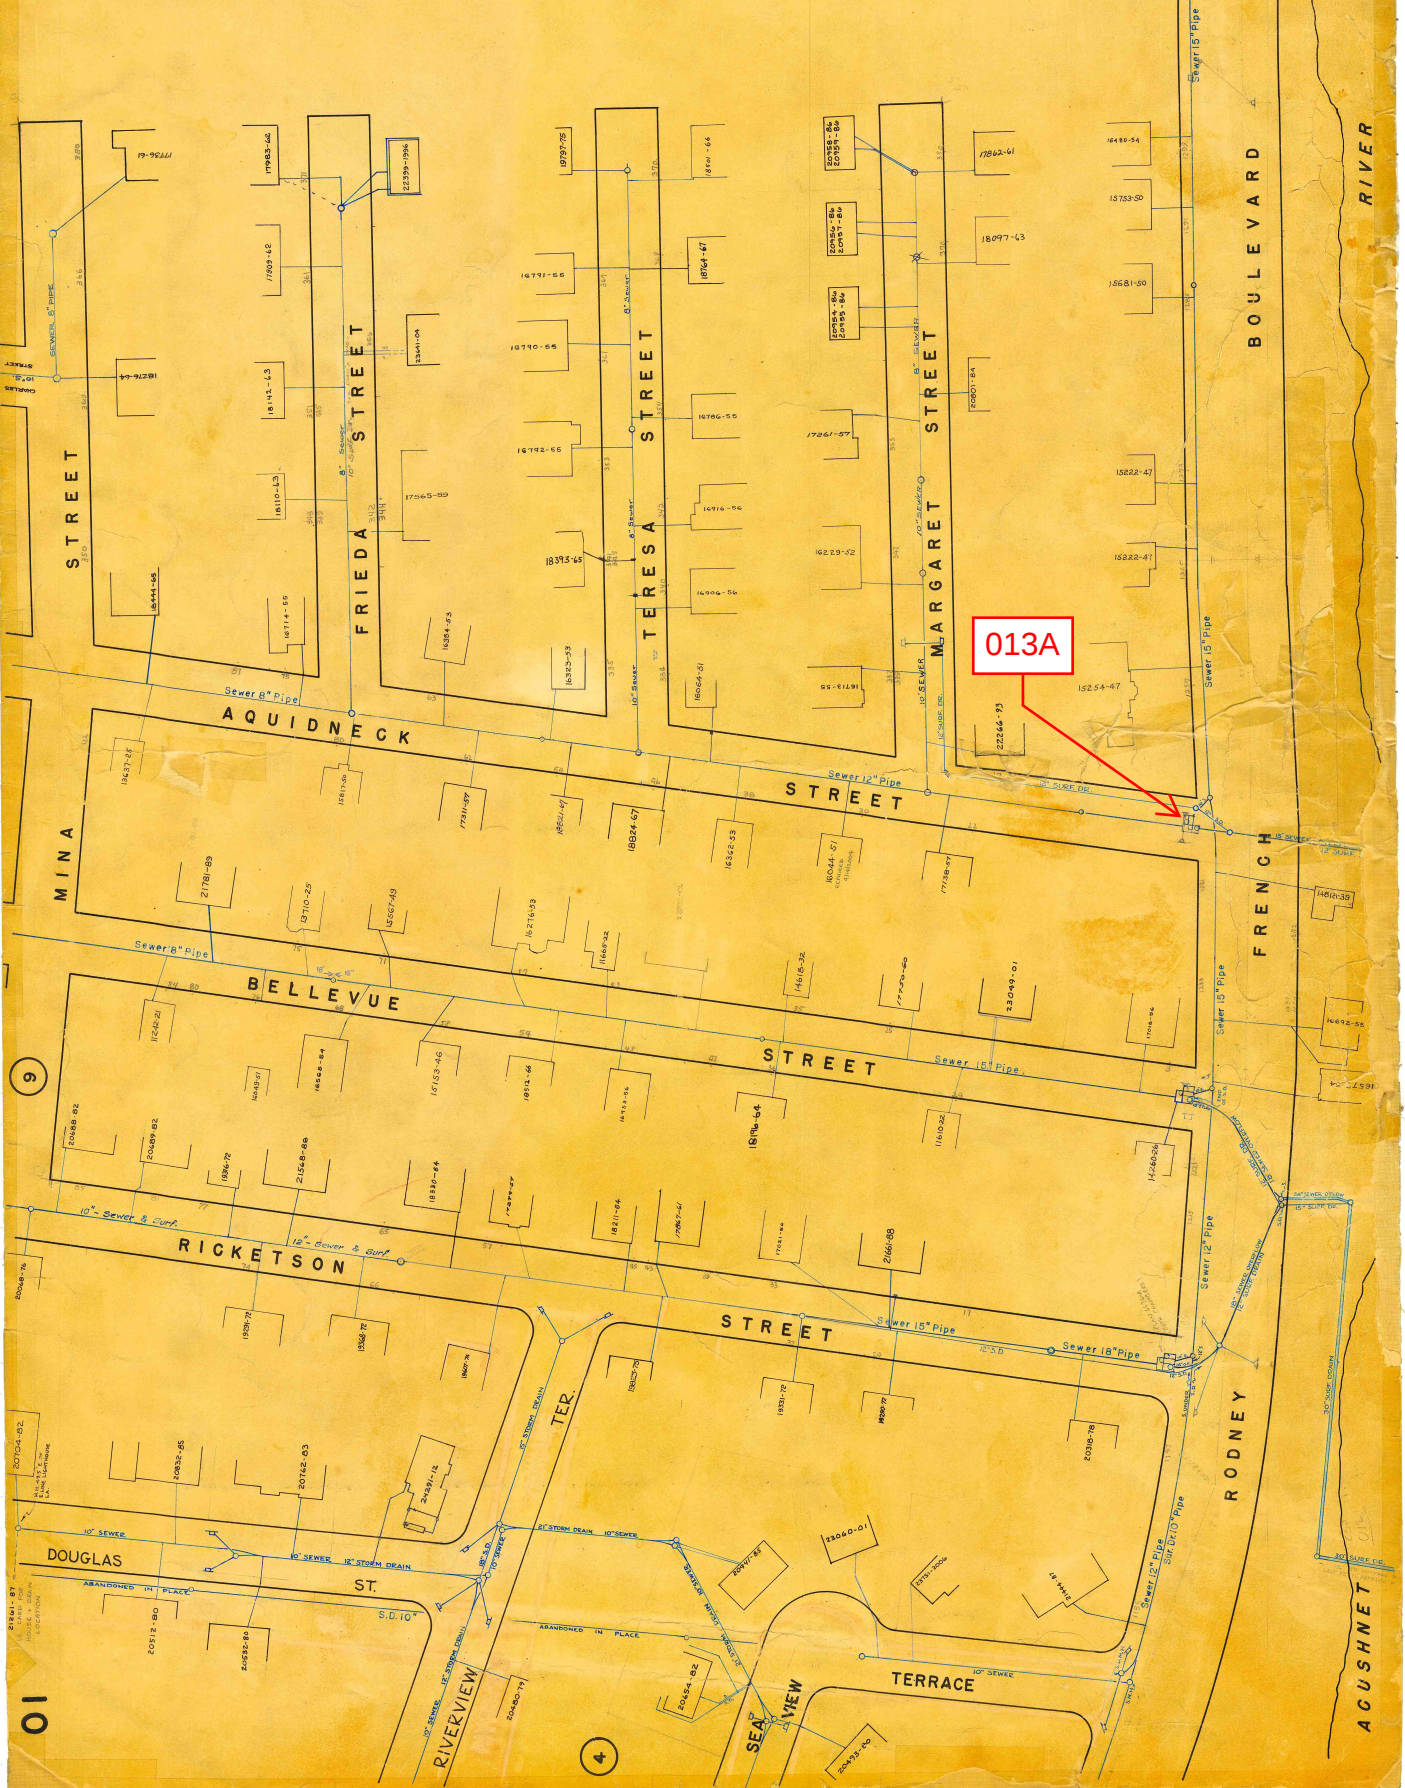
**Figure 1**

**Notes:** Only the inlet chamber was scanned by Redzone in 2023. Other dimensions and elevations were estimated from record drawing-6639A ROD FR BLVD. Tide gate is in good condition, see Figures 1 and 2. It is possible the overflow is blocked further downstream of this structure.

**Figure 1:** Inside of R-013A Regulator Chamber. Inflow, dry weather flow, and overflow visible.
