# **New Bedford Regulator Specification Sheet**

Regulator #: R-020A

**Location:** Wamsutta St. west of Rt. 18 **Date:** 6/25/25

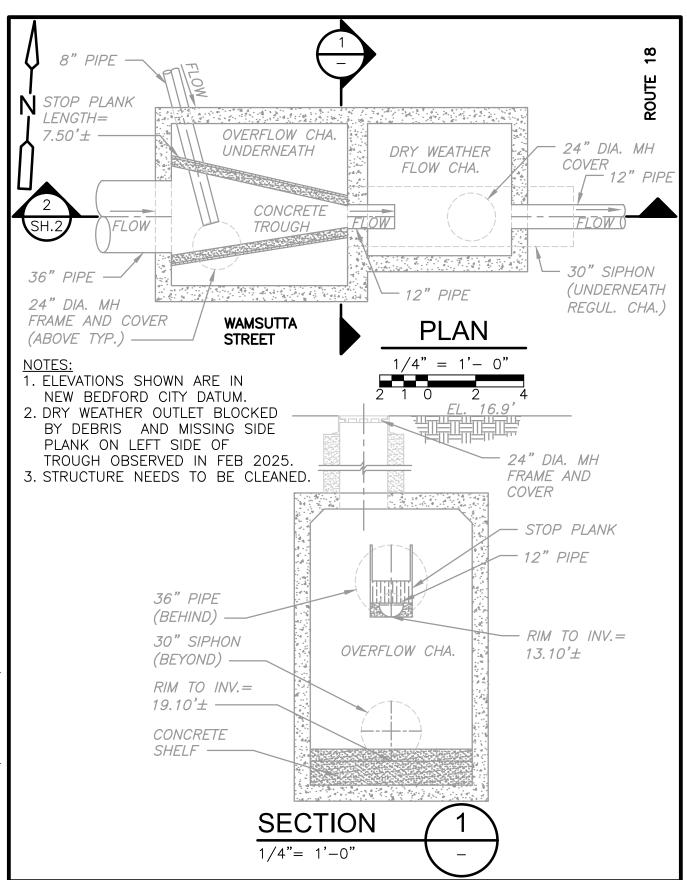
Figure 1

Figure 1: Inside of R-020A. Dry weather flow, weir, and overflow chamber visible.

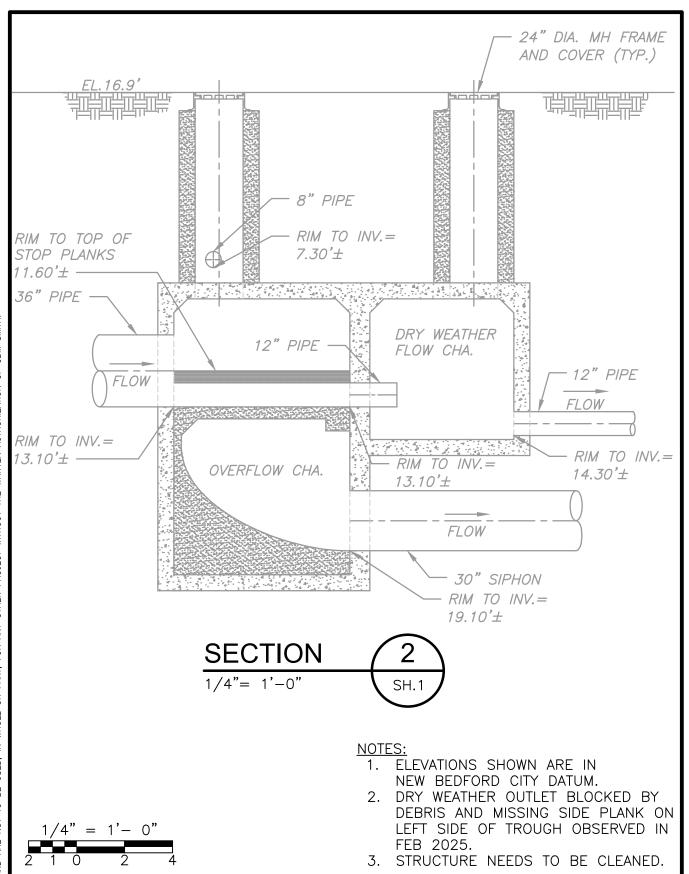
Figure 2

**Notes:** Redzone scanned the inlet chamber in 2023. The second chamber is on the other side of the fence only accessible from Route 18. During Feb 2025 fieldwork, it was discovered that the dry weather outlet was blocked by debris (Figure 2) and a stop plank was missing (not shown). The overflow chamber needs to be cleaned. All other dimensions taken from drawings from MassDOT.

Figure 2: Inside Regulator Chamber of R-020A. Redzone scan taken Dec 2023
