## **CSO SPEC SHEET**

Structure #: REG 026 A

Date: 09/19/2012

#### Structure#: REG 026 A

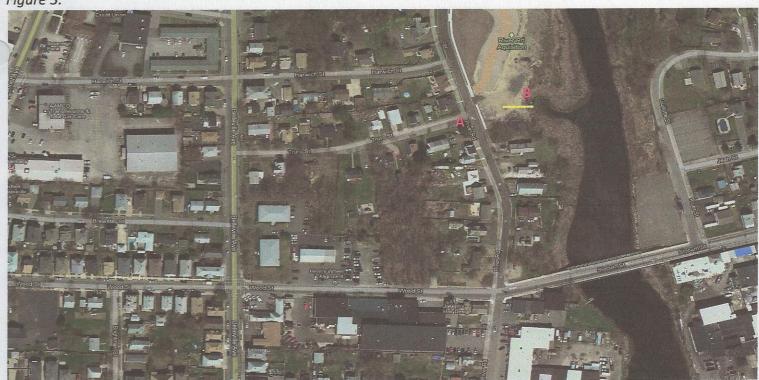
Figure 3.

- Figure 1: View of Regulator 026 A. Facing the Acushnet River.
- Figure 2: Inside view of manhole. A- Sewer; B- Weir Wall; C- Storm Drain.
- Figure 3: Google Earth Image of location of Regulator 026 A. A- Reg 026 A. B- CSO 026 Outfall.
