Project JACOBS ENG WO652463
4/16/2024

Pipe Segment Reference	4/16/2024 7:55:34 AM	Lateral Upstream Access Point	MH1
City	NEW BEDFORD	Lateral Downstream Access Point	OUTFALL
Street	RIVER ROAD	Profile	Egg Shaped 63/48inch
Total Length	130.0	Material	Reinforced Concrete Pipe

Inspection report					
Date: 4/16/2024	Work Order:	Weather:	Surveyed By: JAKE CONNALLY	Certificate Number: P0037360	Pipe Segment Ref.: 4/16/2024 7:55:34 AM
Year laid:	Pre-cleaning: No Pre-Cleaning	Direction: Upstream	Pipe Joint Length:	Total Length: 130.0 '	Length Surveyed: 130.0 '

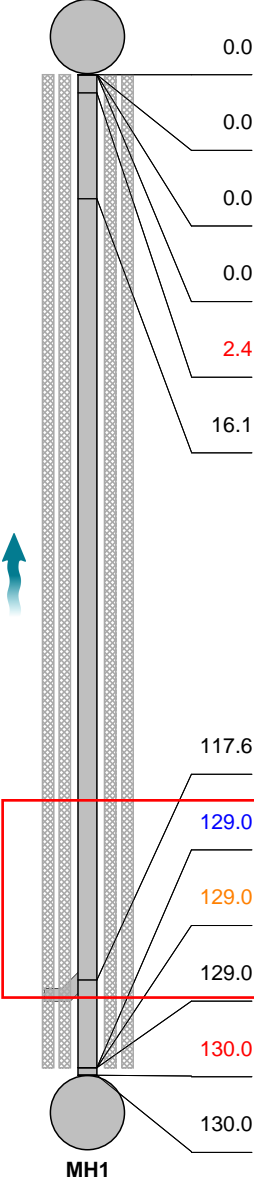
1:982	Distance	Code	Observation	Counter	Photo	Grade
OUTFALL

0.0	AEP	End of Pipe / OUTFALL	00:00:00	1	
	0.0	MWL	Water Level, 0% of the vertical dimension	00:00:05	2

0.0 S01	DSF	Deposits Settled Fine, 5% of cross sectional area from 4 o'clock to 8 o'clock, Start	00:00:12	3	
	0.0 S02	CM	Crack Multiple from 12 o'clock to 12 o'clock, Start	00:00:52	4, 5

2.4	SMW	Surface Damage Missing Wall at 10 o'clock	00:01:38	6	S5
	16.1	MGO	Miscellaneous General Observation / POSSIBLE HOLE. COULD BE FOR GROUND WATER	00:03:35	7

129.0 F02	CM	Crack Multiple from 12 o'clock to 12 o'clock, Finish	00:13:11	11	S3
	129.0	MGO	Miscellaneous General Observation / SEPERATION	00:13:23	12, 13
