# R-027C

BELLEVILLE AVE  
New Bedford

Inspection Status: Remote Inspection  
Inspection Level: Level 2

**Project:** | New Bedford 3D Regulator Inspections

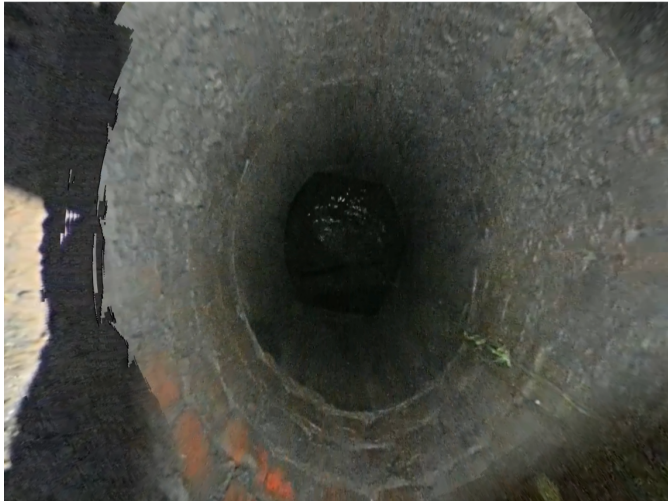
Code: **MGO**  
Description: **Miscellaneous General Observation**

Distance: **0ft**  
Structural Grade: **0**  
O&M Grade: **0**  
Clock Start/From:  
Clock To:  
1st Value:  
2nd Value:  
Value Percent:  
Continuous Index:  
Within Eight" of Joint: **False**  
Remarks: **Start inspection**

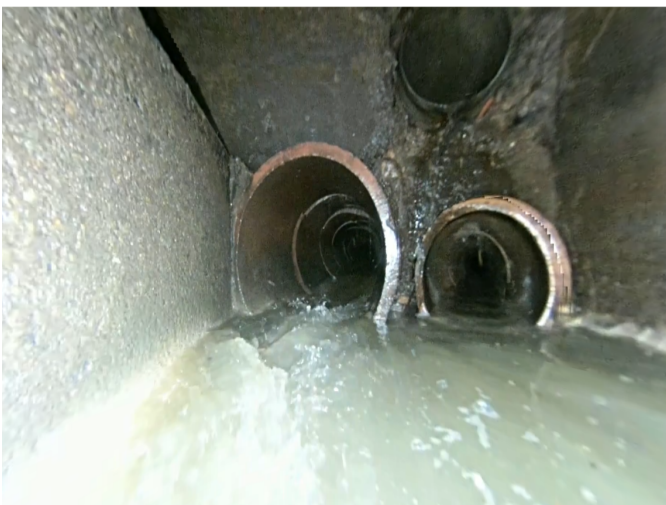
Code: **MGO**  
Description: **Miscellaneous General  
Observation**

Distance: **10ft**  
Structural Grade: **0**  
O&M Grade: **0**  
Clock Start/From:  
Clock To:  
1st Value:  
2nd Value:  
Value Percent:  
Continuous Index:  
Within Eight" of Joint: **False**  
Remarks: **End inspection**
