R-031D

GRINNELL ST
New Bedford

Inspection Status: Remote Inspection
Inspection Level: Level 2

Project: | New Bedford 3D Regulator Inspections

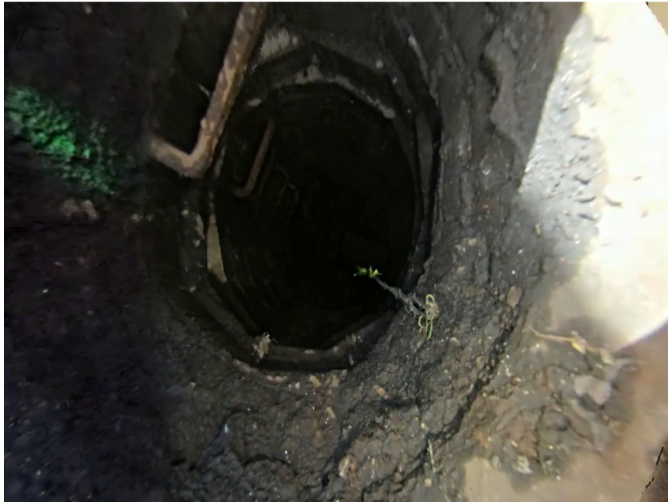
Code: **MGO**
Description: **Miscellaneous General Observation**

Distance: **0ft**
Structural Grade: **0**
O&M Grade: **0**
Clock Start/From:
Clock To:
1st Value:
2nd Value:
Value Percent:
Continuous Index:
Within Eight" of Joint: **False**
Remarks: **Start inspection**

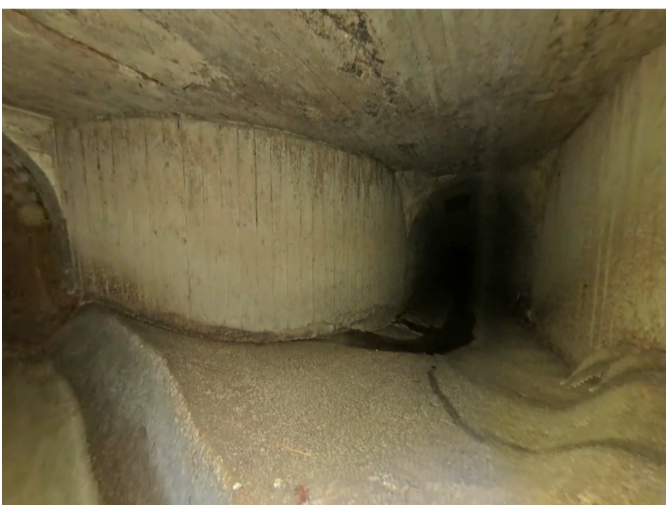
Code: **MGO**
Description: **Miscellaneous General
Observation**

Distance: **10ft**
Structural Grade: **0**
O&M Grade: **0**
Clock Start/From:
Clock To:
1st Value:
2nd Value:
Value Percent:
Continuous Index:
Within Eight" of Joint: **False**
Remarks: **End inspection**
