R-032A

S 2ND ST
New Bedford

Inspection Status: Remote Inspection
Inspection Level: Level 2

Project: | New Bedford 3D Regulator Inspections

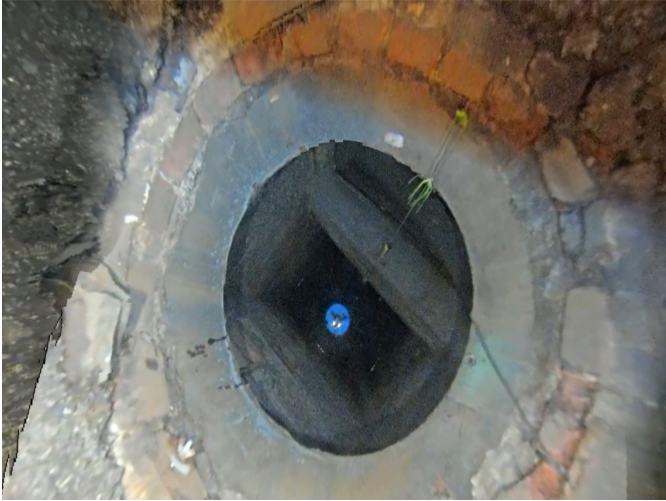
Code: **MGO**
Description: **Miscellaneous General Observation**

Distance: **0ft**
Structural Grade: **0**
O&M Grade: **0**
Clock Start/From:
Clock To:
1st Value:
2nd Value:
Value Percent:
Continuous Index:
Within Eight" of Joint: **False**
Remarks: **Start inspection**

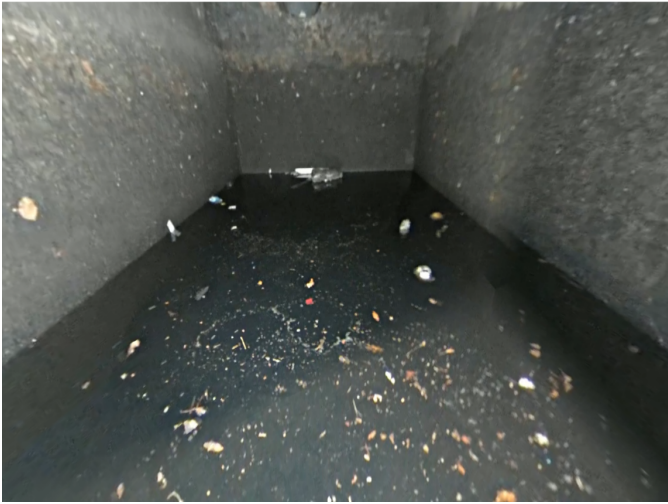
Code: **MGO**
Description: **Miscellaneous General Observation**

Distance: **8ft**
Structural Grade: **0**
O&M Grade: **0**
Clock Start/From:
Clock To:
1st Value:
2nd Value:
Value Percent:
Continuous Index:
Within Eight" of Joint: **False**
Remarks: **End inspection**
