APPLICATION No.: 11254

LOCATION: 176 - 178 Rockland St

10/24/2018 Lead Service Replacement Program

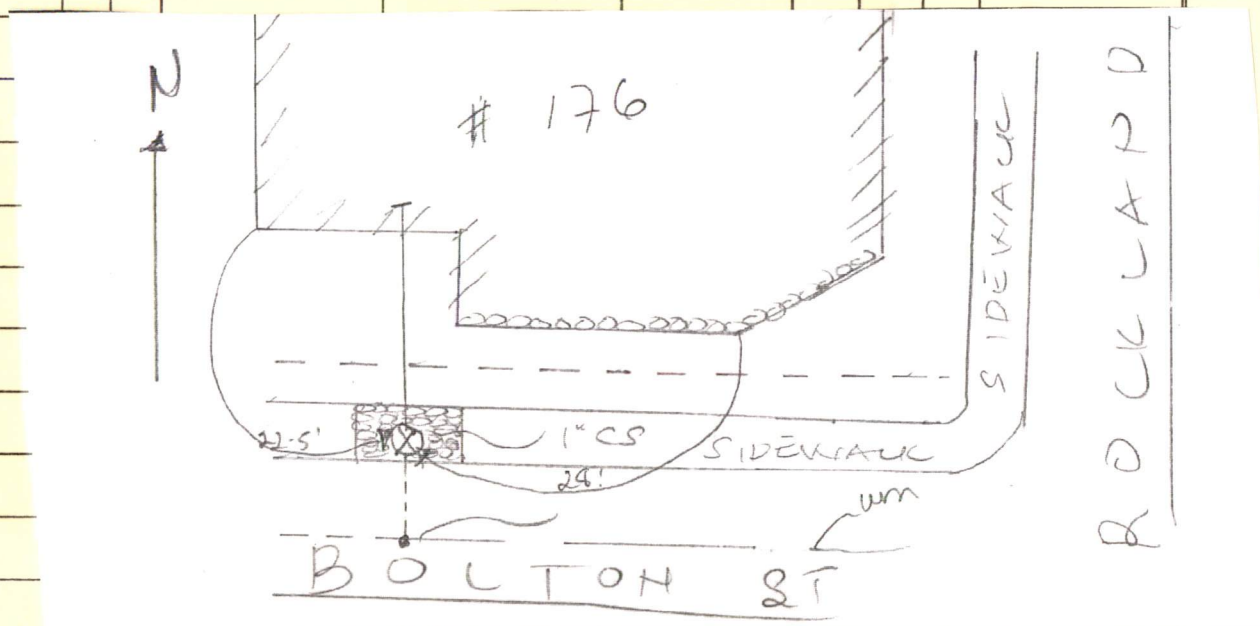
LOCATION: 176-78 Rockland St.OWNER: Lionel FerreiraMEASURES: 5/8" H lead Nov. 16, 1905S from Rockland St. 25.2 ft.E from W line Bolton St. 9.5 ft.N from S line body of house 10.2 ft.
