✓ APPLICATION No.: 8872

LOCATION: 16 Viall St

MEASURES: 4/9/2019 1" Copper Service  
Lead Service Line Replacement Program  
Phase 1, Contractor P Gioioso & Son  
Type CU, Diameter 1in, Water pressure 100  
Distance from curb stop to main (ft) 27  
Distance from curb stop to meter (ft) N/A  
Distance from curb face to curb stop (ft) 2  
Depth of service (ft) 4  
Total length of new pipe installed (ft) 27  
Curb stop replaced: Yes size 1"  
Corporation replaced: No  
Ball valve replaced: NO

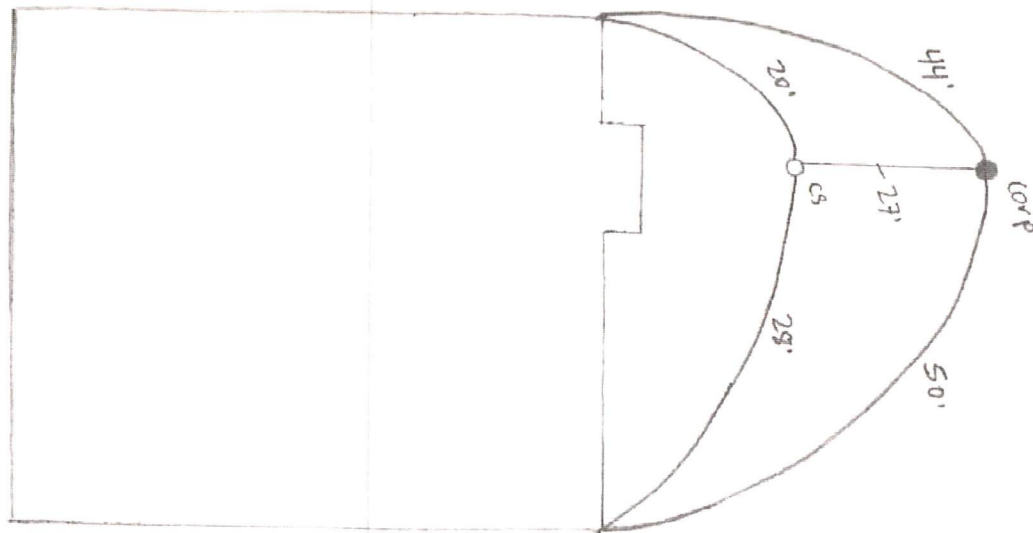
APPLICATION No.: 8872

S from  
W from E  
N from S

Cove ST.  
Viall  
house

285.5 ft.  
9.1 ft.  
7.0 ft.

May 10 , 1960 Renewed from a point 1 ft. inside prop.  
line to inside cellar.

7 ft. - 3/4" Copper tubing

Aug. 18, 1975 Renewed from  $\frac{1}{2}$  ft. outside curb stop to the property line.

9½ ft. - 3/4" Copper tubing
