## CSO SPEC SHEET

Structure #: REG 004 A

## CSO FIELD PHOTOS

Structure#: Regulator 004A

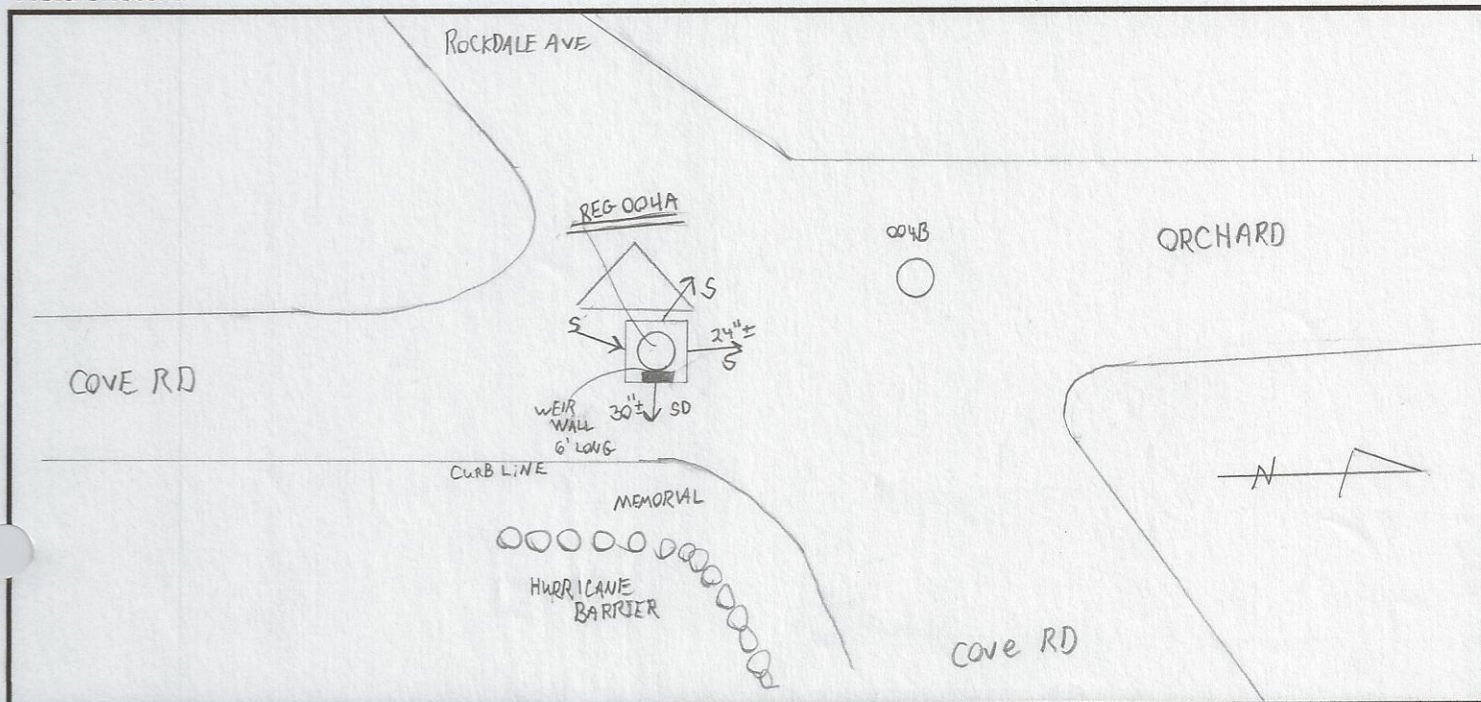
Field Sketch:

Regulator Type: Weir Wall/Block regulator

Weir Dim's: 1' x 6'

Rim to Top of Weir: 6.5'

Rim to Storm Drain Invert: 7.6'

Rim to Top of Sewer (Normal Flow): 8.1'

Free Board: 1.6'

Comments: No repair needed as of 8/17/2012.

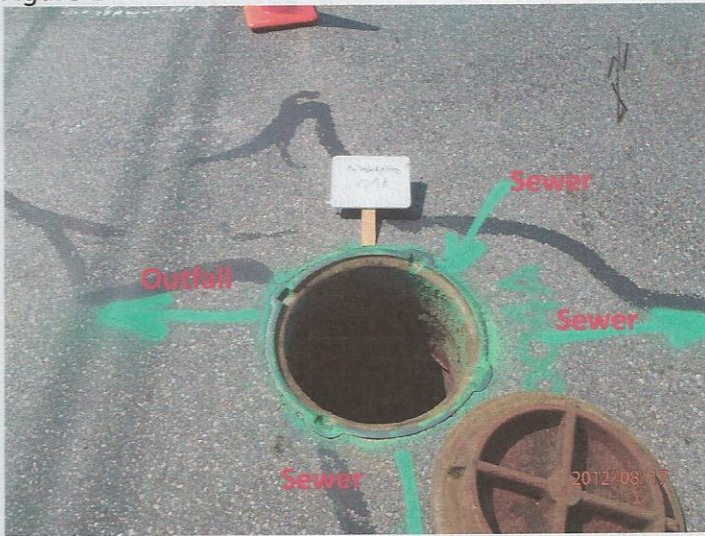
Figure 1.

**Figure 1:** Street view of open manhole to regulator 004A showing sewer incoming and outgoing directions as well as the storm drain outfall.

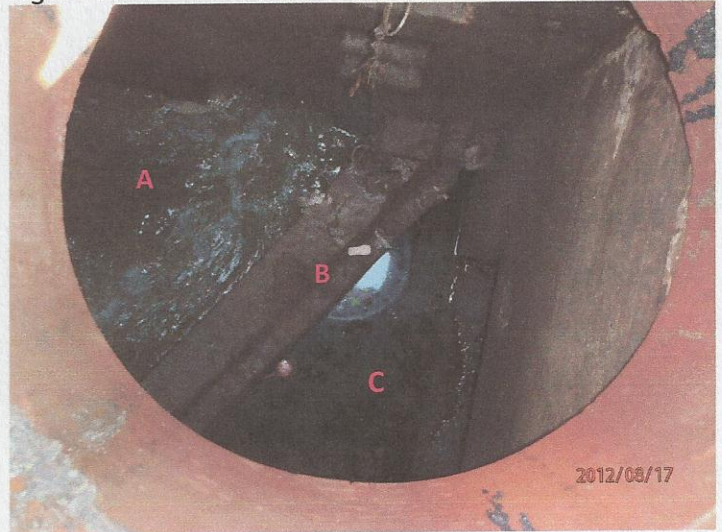
Figure 2.

**Figure 2:** Inside view of manhole. A- Sewer; B- Weir Wall; C- Storm Drain.

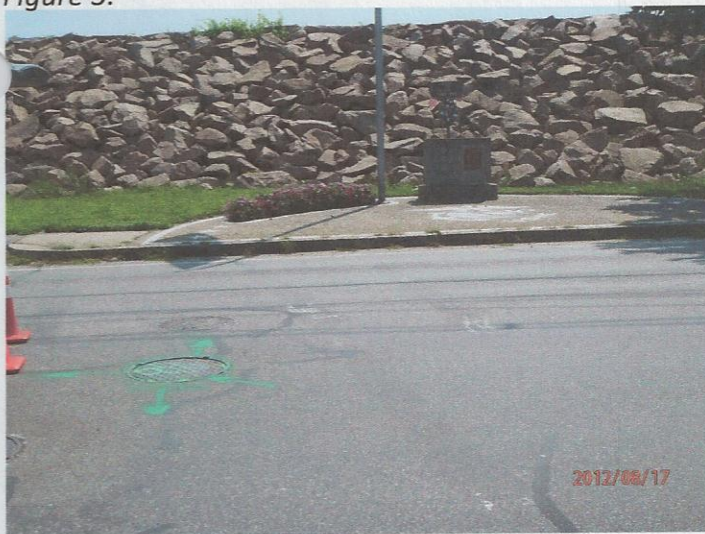
Figure 3.

**Figure 3:** Street view of Regulator 004A, Facing the Hurricane Barrier and a memorial.
