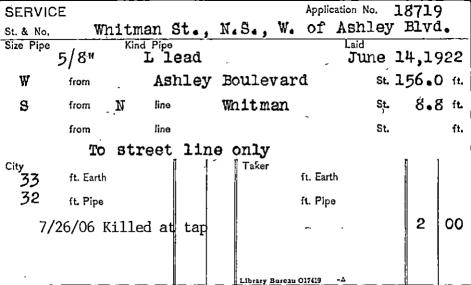
7/26/06 Killed at tap & removed old c/s box Bento

Street cut: 6' x 4' Warr. S/W cut: 2' x 2' Grass

Stock: 1 - 3/4" Corporation tap 1 - 6" x 3/4" Service Saddle

Note: Water main very weak; 5/8" tap blew out off the main. (Service not in use)
