APPLICATION No.: app. 24363

DRY WEATHER ADJUSTMENT FACILITIES PROJECT  
NEW BEDFORD, MA.

WATERMAIN RELOCATION NO. FRONT BETW. LOGAN &amp; WAMSUTTA

NO. FRONT ST - CONNECTIONS OF EXISTING SERVICES TO NEW MAIN

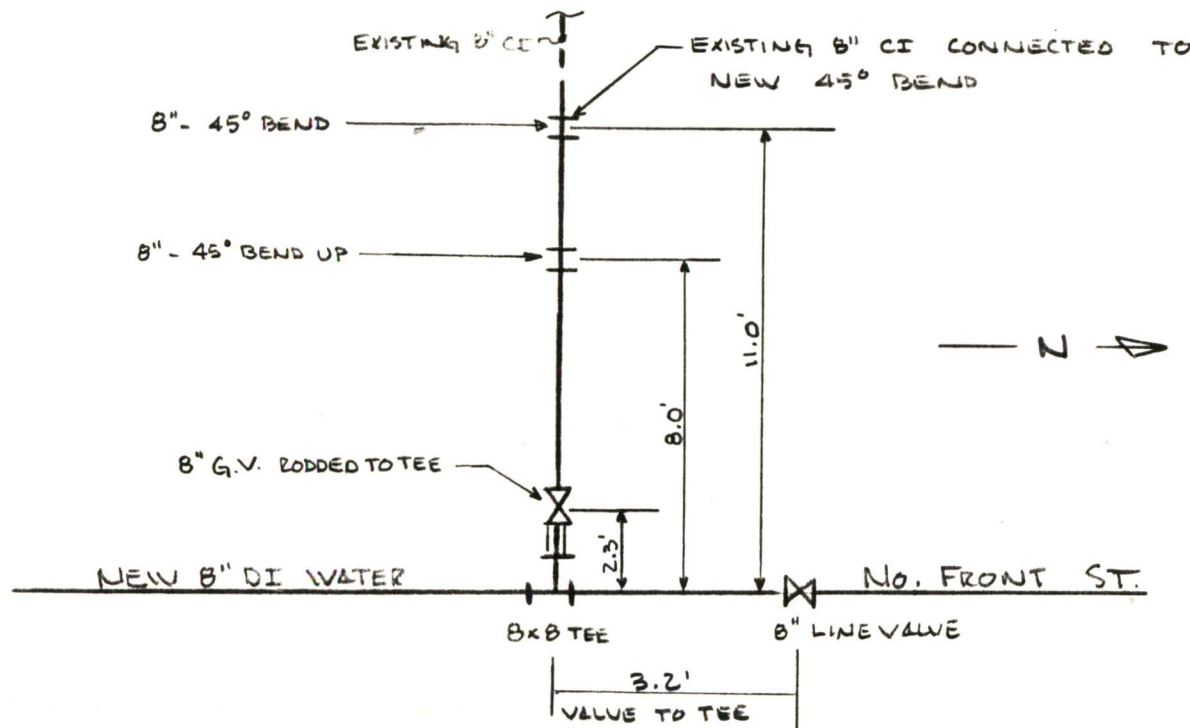
① 8" FIRE SERVICE TO NATIONAL WHOLESALE COMPLEX

Sept. 1989 Relocated ser. Y from old abandoned 8" main to new 8" ductile main as part of new sewer & drain project:  
Renewed from new 8" x 8" x 8" tee on newly installed 8" ductile main to a point 11 ft. from main: see sketch

Measures of new 8" gate valve: N x N line Wamsutta S t. 394.4 ft.  
E x W line No. Front S t. 14.0 ft.

01.27.2025 Contractor JLC Construction Inspectors Percy Reynolds / Devin Ponte  
Inspection done on repair to domestic service (24364) at this time it was discovered that the fire supply (24363) had been disconnected (at time unknown) and is no longer being used. Domestic line is running up the center of the 8" fire supply tap at city main.

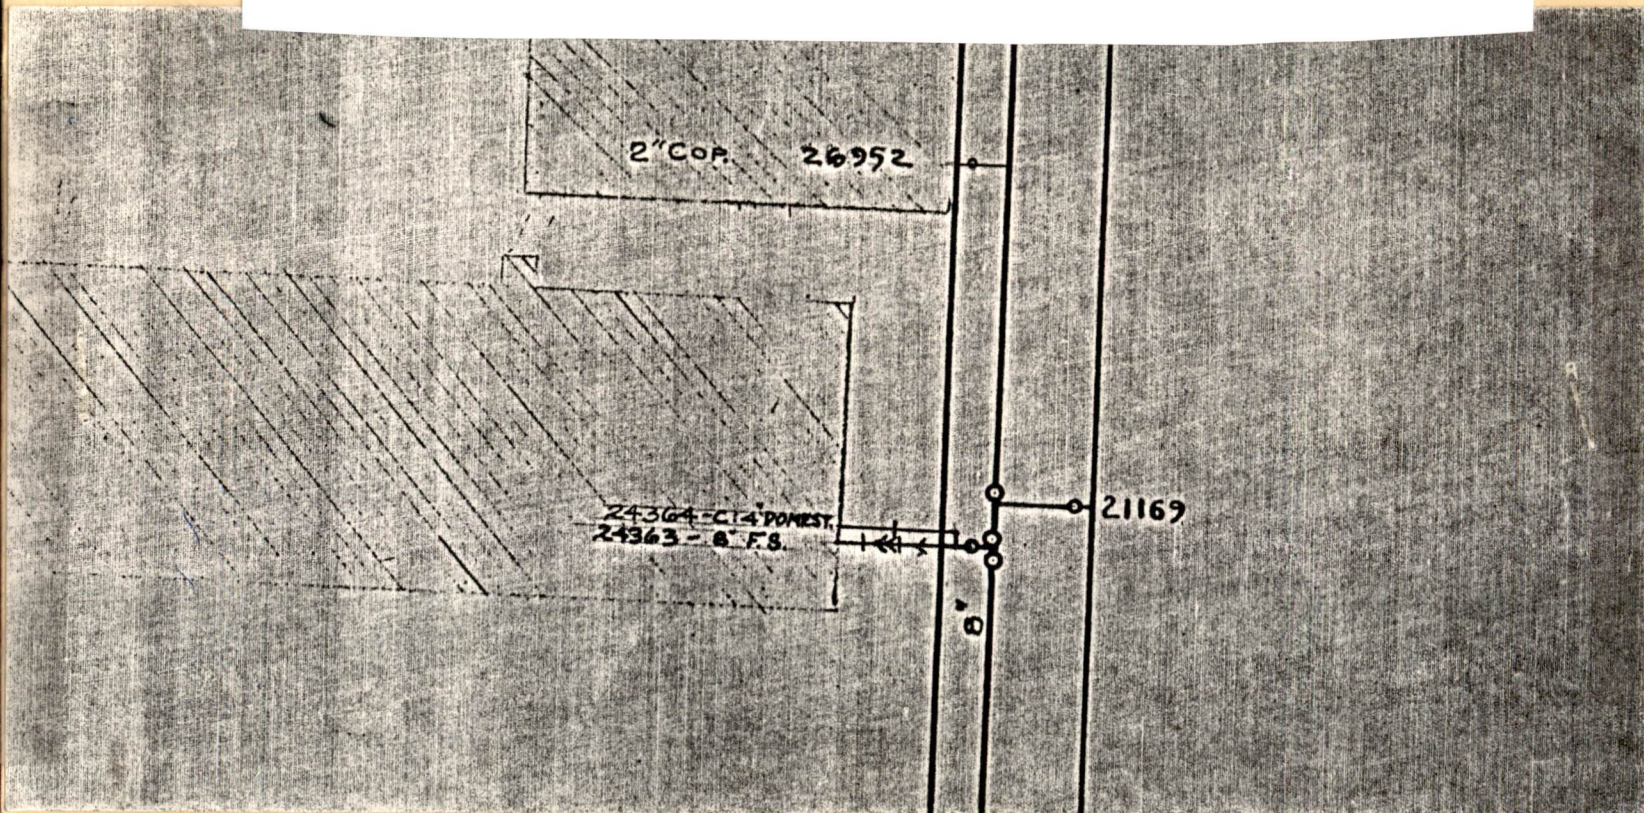
MEASURES: 01.27.2025 Contractor JLC Construction Inspectors Percy Reynolds / Devin Ponte  
 Inspection done on repair to domestic service (24364) at this time it was discovered that the fire supply (24363)  
 had been disconnected (at time unknown) and is no longer being used. Domestic line is running up the center  
 of the 8" fire supply tap at city main.
